REPORT OF DR. FOLKERS ROJAS, P.E.

DATED this 18th day of February 2025.

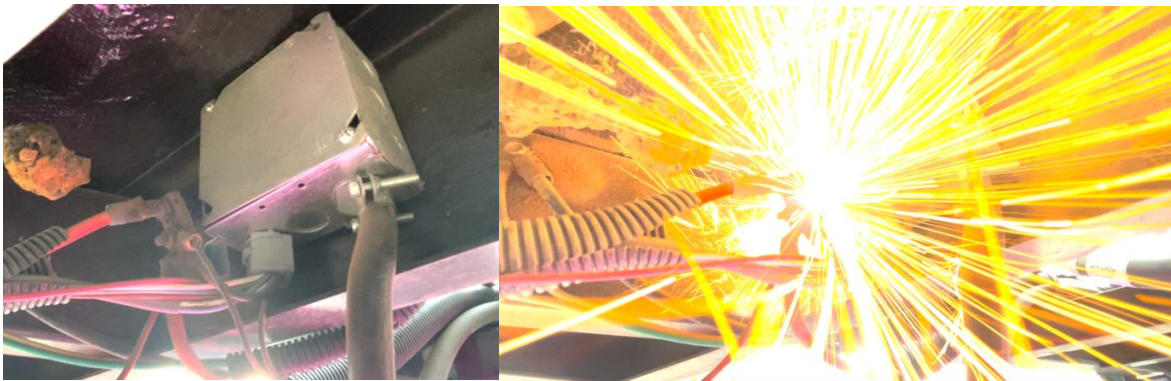
124. A 2021 Wolf Pup had no strain relief on the wiring connected to the automatically resettable mini-breaker. The mini breaker had detached from the RV frame allowing for the battery side stud of the mini-breaker to make contact with a metal junction box resulting a short and sparks. The RV dealer was immediately notified of the present danger with that particular unit.

Figure 28. 2021 Wolf Pup found in dealer lot with battery installed and disconnected breaker [Exhibit]

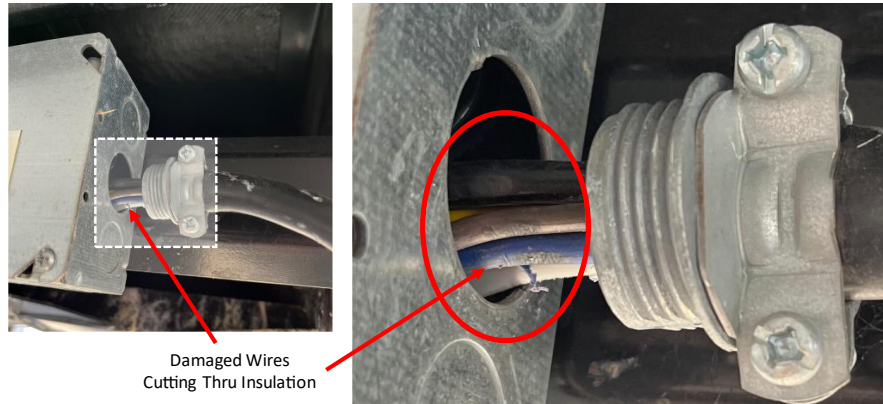
125. The wire insulation can be damaged using the hardware and methods that Forest River is currently using. The wire insulation can be damaged due using the improper wire clamp and not strain relieving the connection correctly. The connector to the junction box first gets disconnected from the junction box. Slowly as the cables dangle the edge of the junction box starts to wear away either slowly or catastrophically. Figure 29 shows how the insulation of the seven-way wiring can start to wear away after the wire clamp nut comes loose due to vibrations of the towable RV. The wire shows damage where insulation is beginning to be shaved off. Figure 30 shows an Arlington plastic push-in connector that got loose and sections of the bare exposed white wire. Both of these have been seen in the RV sales lots.

Figure 29. Damaged insulation Wiring on a 2019 Rogue Vengeance due to improper electrical clamp used (VIN 5zt3vgwbx1001654).

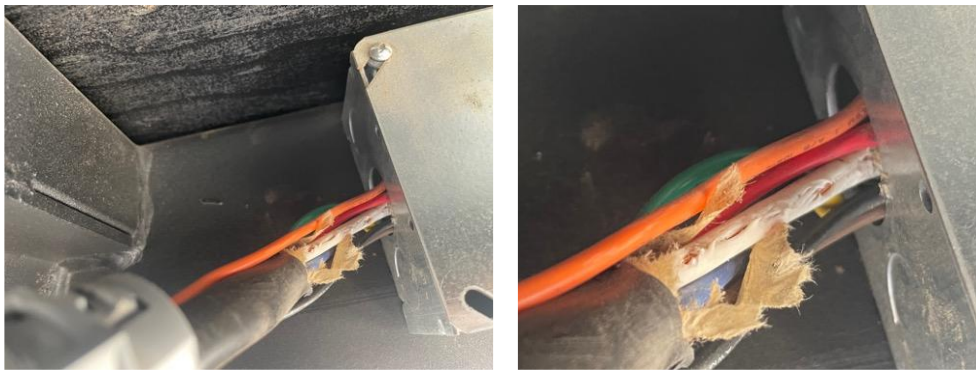
Figure 30. Damaged insulation Wiring on a 2022 Palomino Puma due to improper electrical clamp used (VIN 4x4fptp23pp098788).

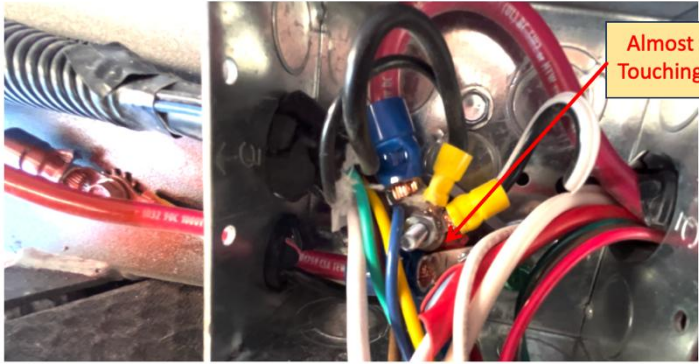
<p>Almost Touching</p>
<p>Model: Ahara East to West</p> <p>VIN: 5zt3ah3b8n9100287</p> <p>Fabricated Date: 5/19/22</p>

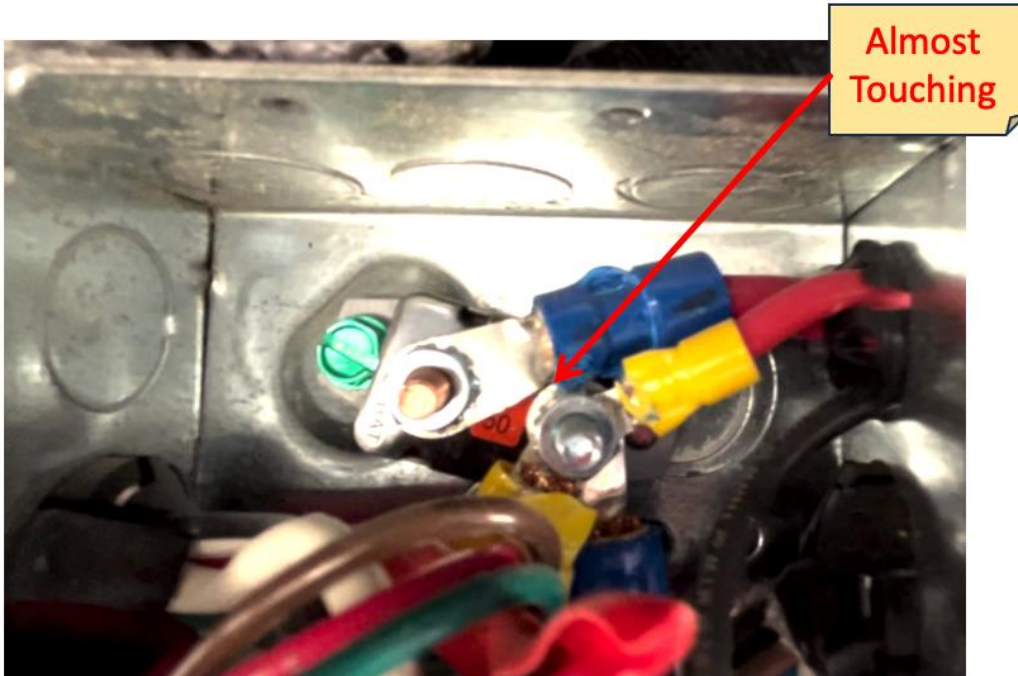
Figure 31. Silver Lake by East to West travel trailer with battery line that includes mini breaker yet the battery cable has no strain relief and the terminal ends are almost touching (VIN 5nhtsvy28sg001947)

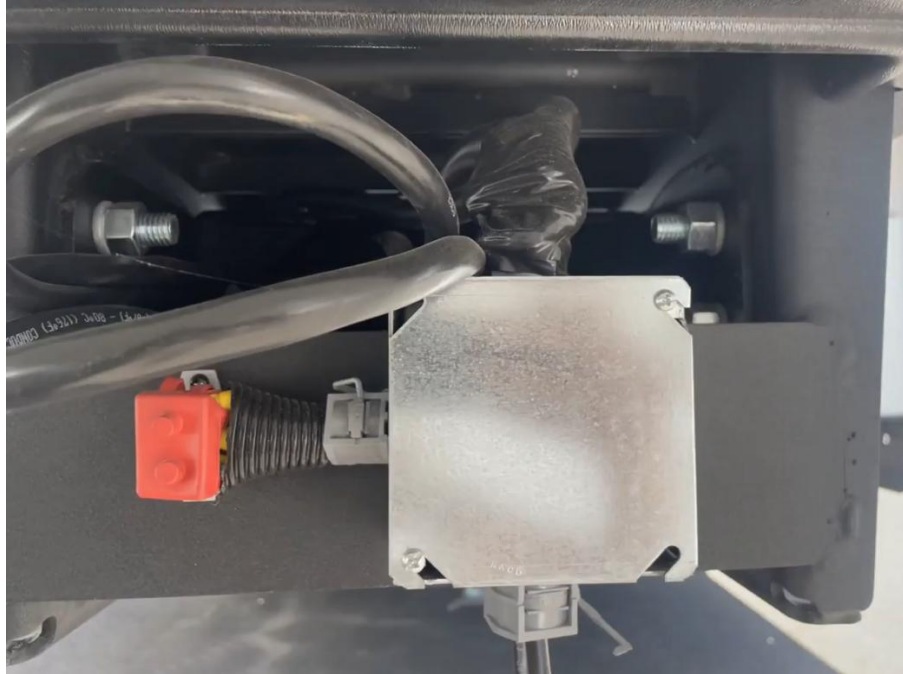
Figure 34. Sample shown of Columbus manufactured on 8/21/2024 (VIN: 4x4fcmp25s6014762)

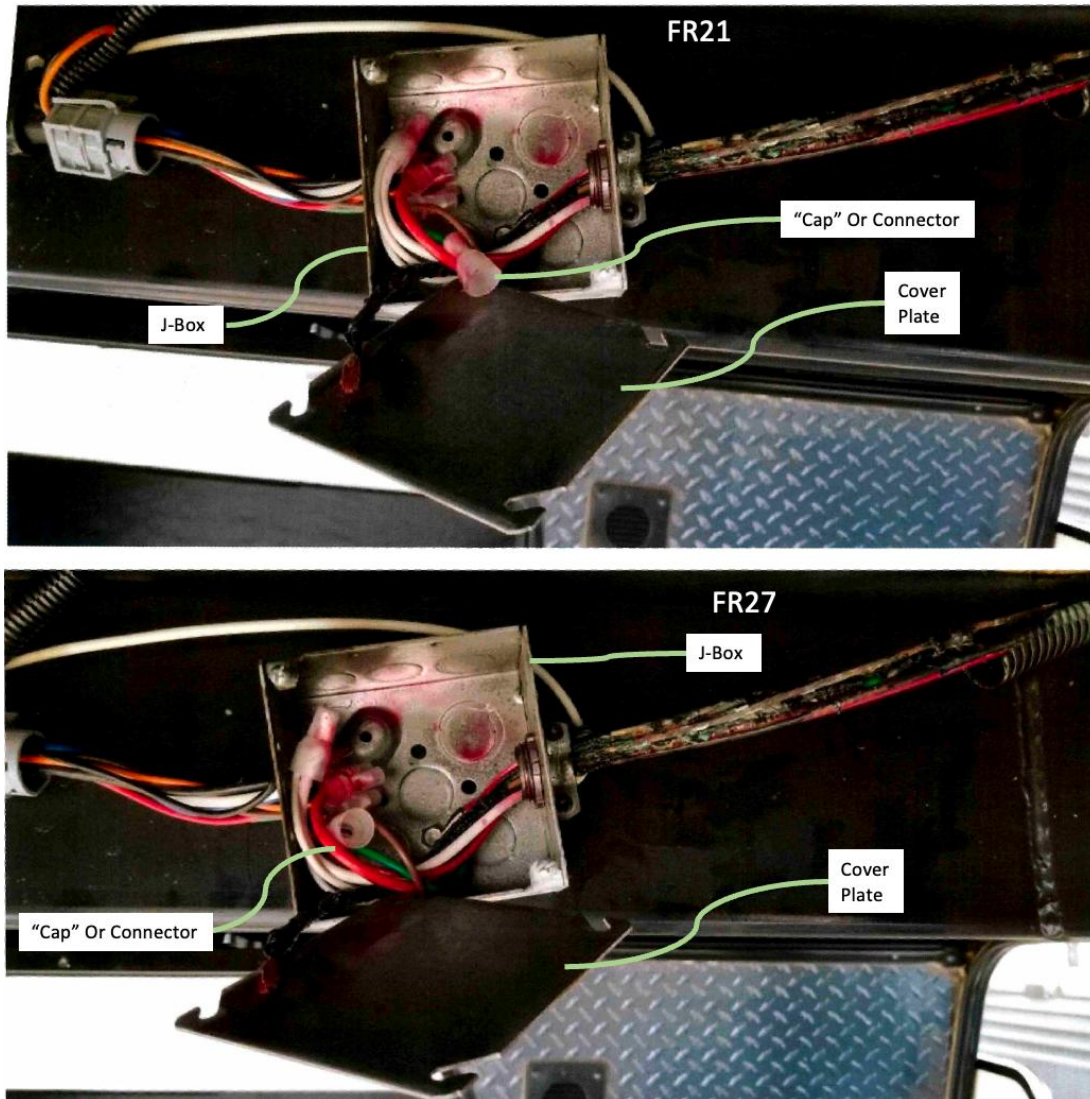
Figure 38. Nelson's 2019 Puma after fire incident due to seven-way wiring defects. The images are from ForestRiver0000021 and ForestRiver0000027.

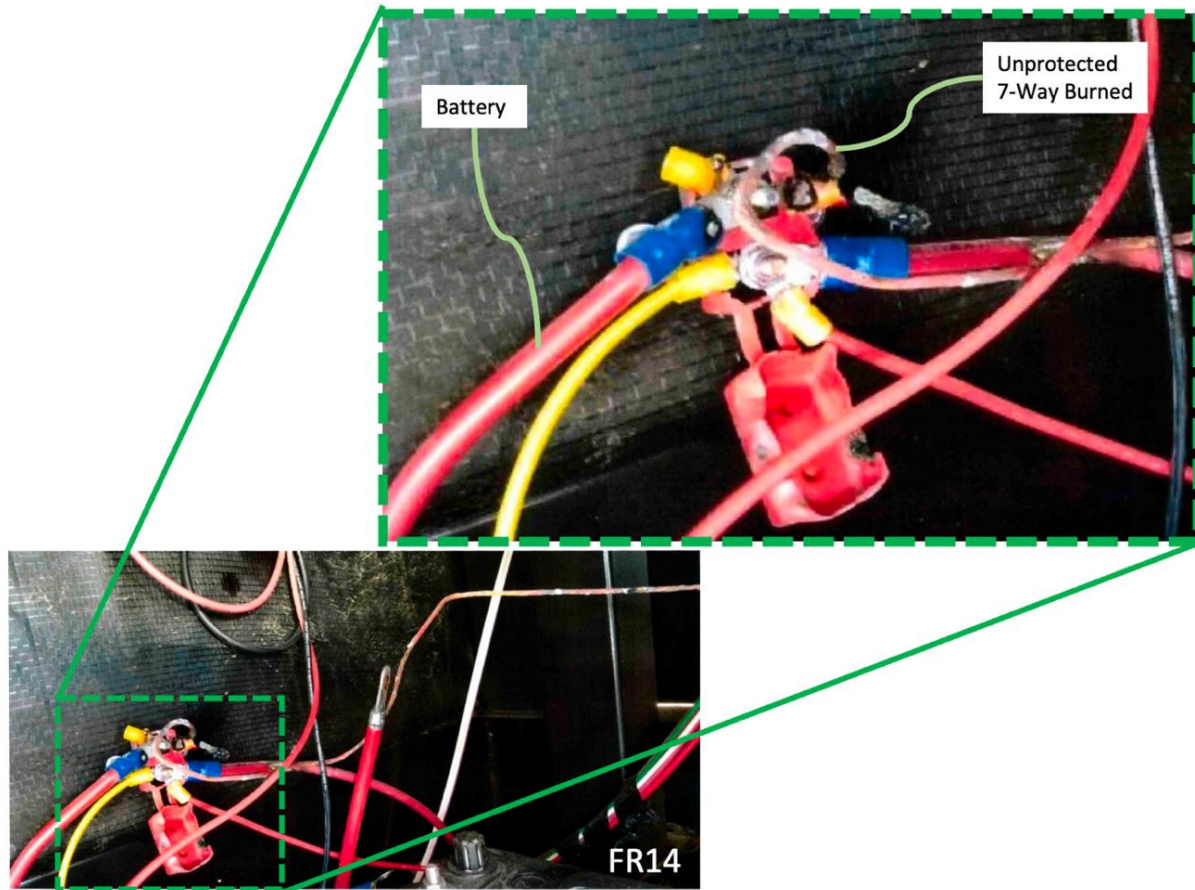
Figure 39. Nelson's 2019 Puma after fire incident showing the breaker region with a single Mini breaker and the 7-way charge line directly connected the unprotected side. Simply put the 7-way charge line is directly connected to the battery.

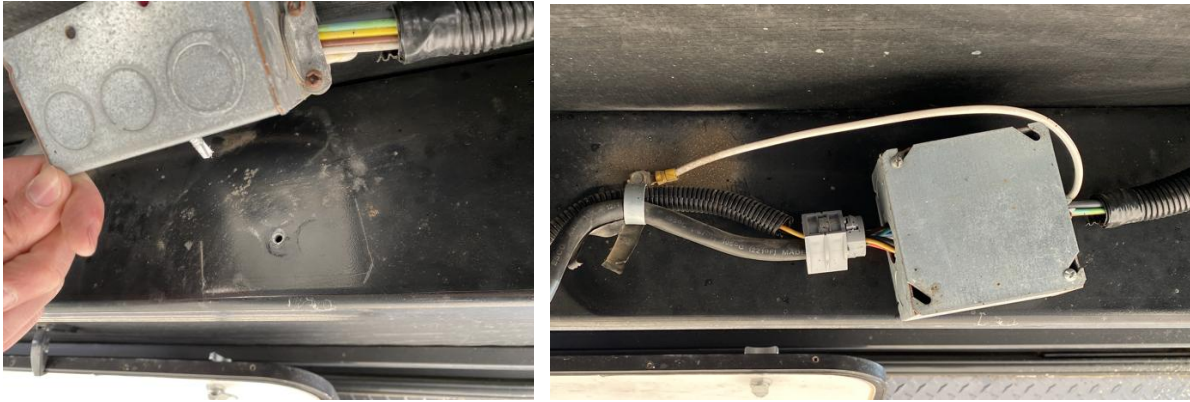
Figure 40. Forest River 2019 Puma junction box region on November 13, 2024

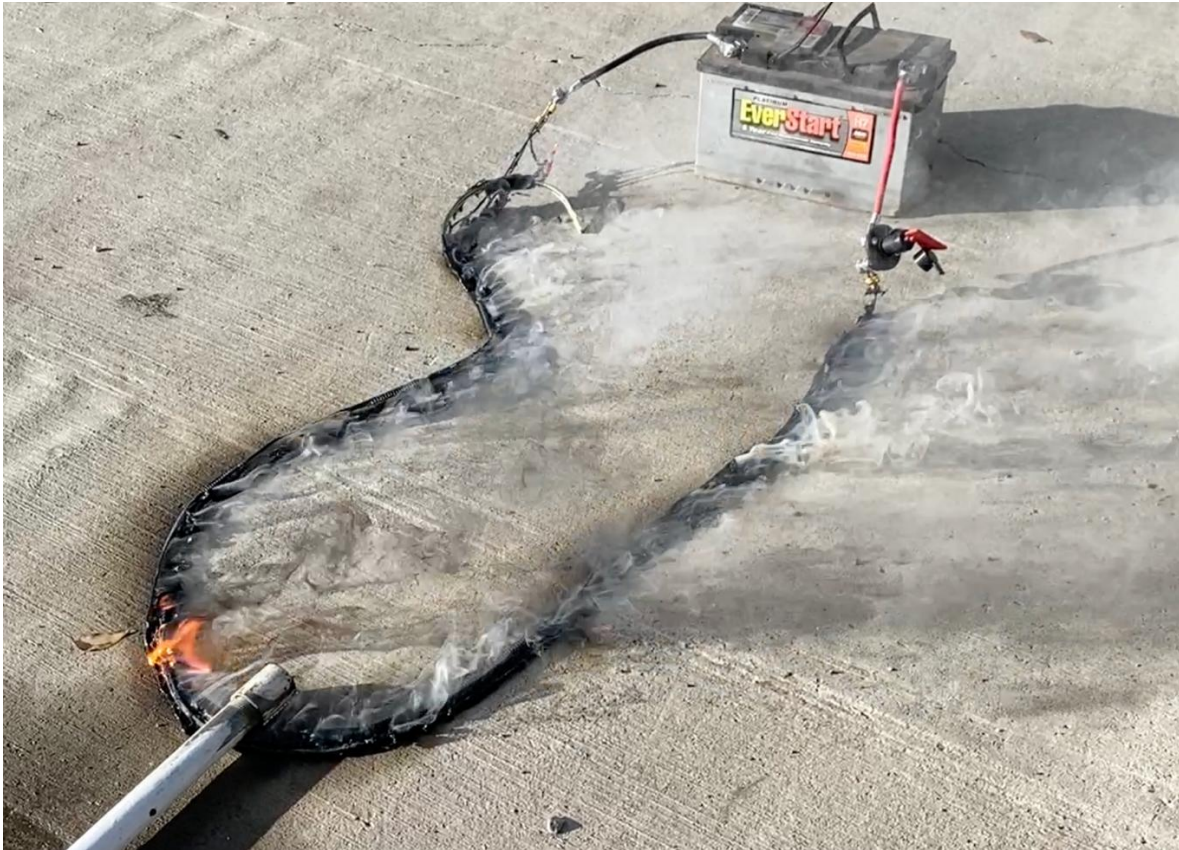
203. Within 70 second of the short flames were established as shown below:

Figure 46. Dual wire experiment flames established and sustainable by the burning insulation Image was captured at time stamp 1:32 which is 74 seconds after the initiation of the short.

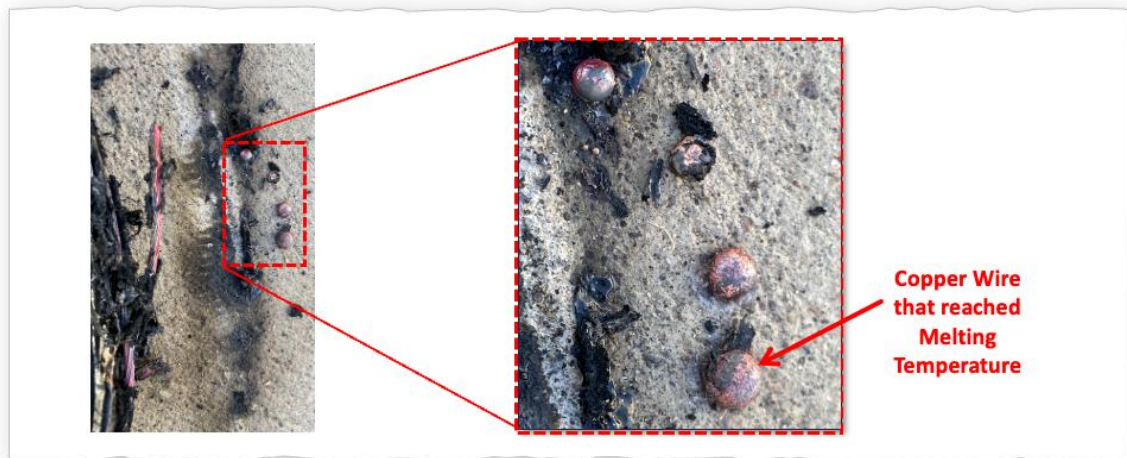
Figure 47. Evidence of temperature provided by the molten copper spheroids left

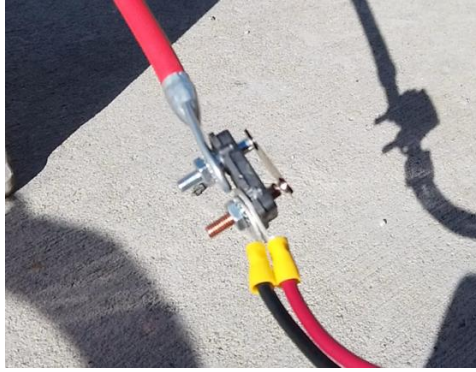
Figure 48. Exposed bi-metallic strip of 30-amp breaker
